## MEMORANDUM

RE: CHEMICAL RECOVERY SYSTEMS SITE VISIT

DATE: 6/27/2012

**Chemical Recovery Systems Site Photographs, U.S. EPA Region 5**

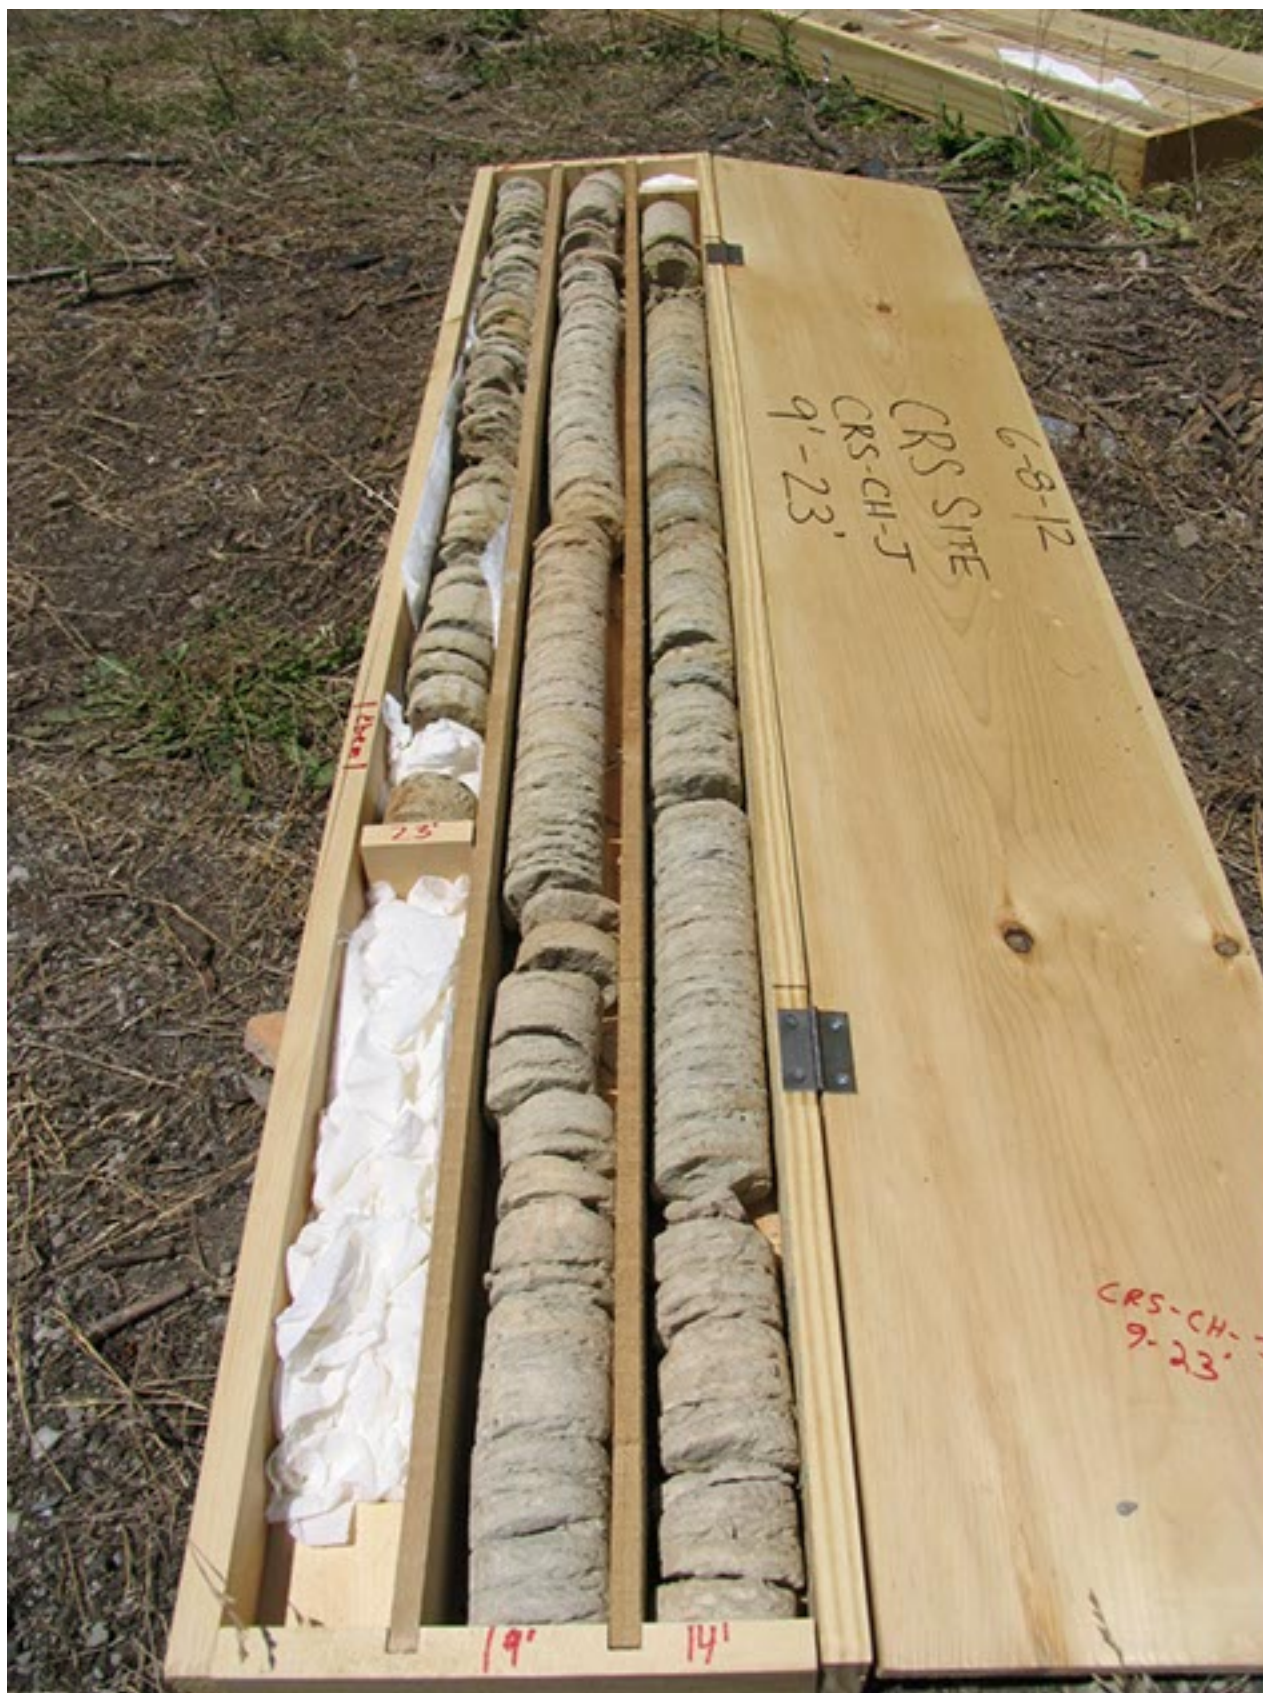
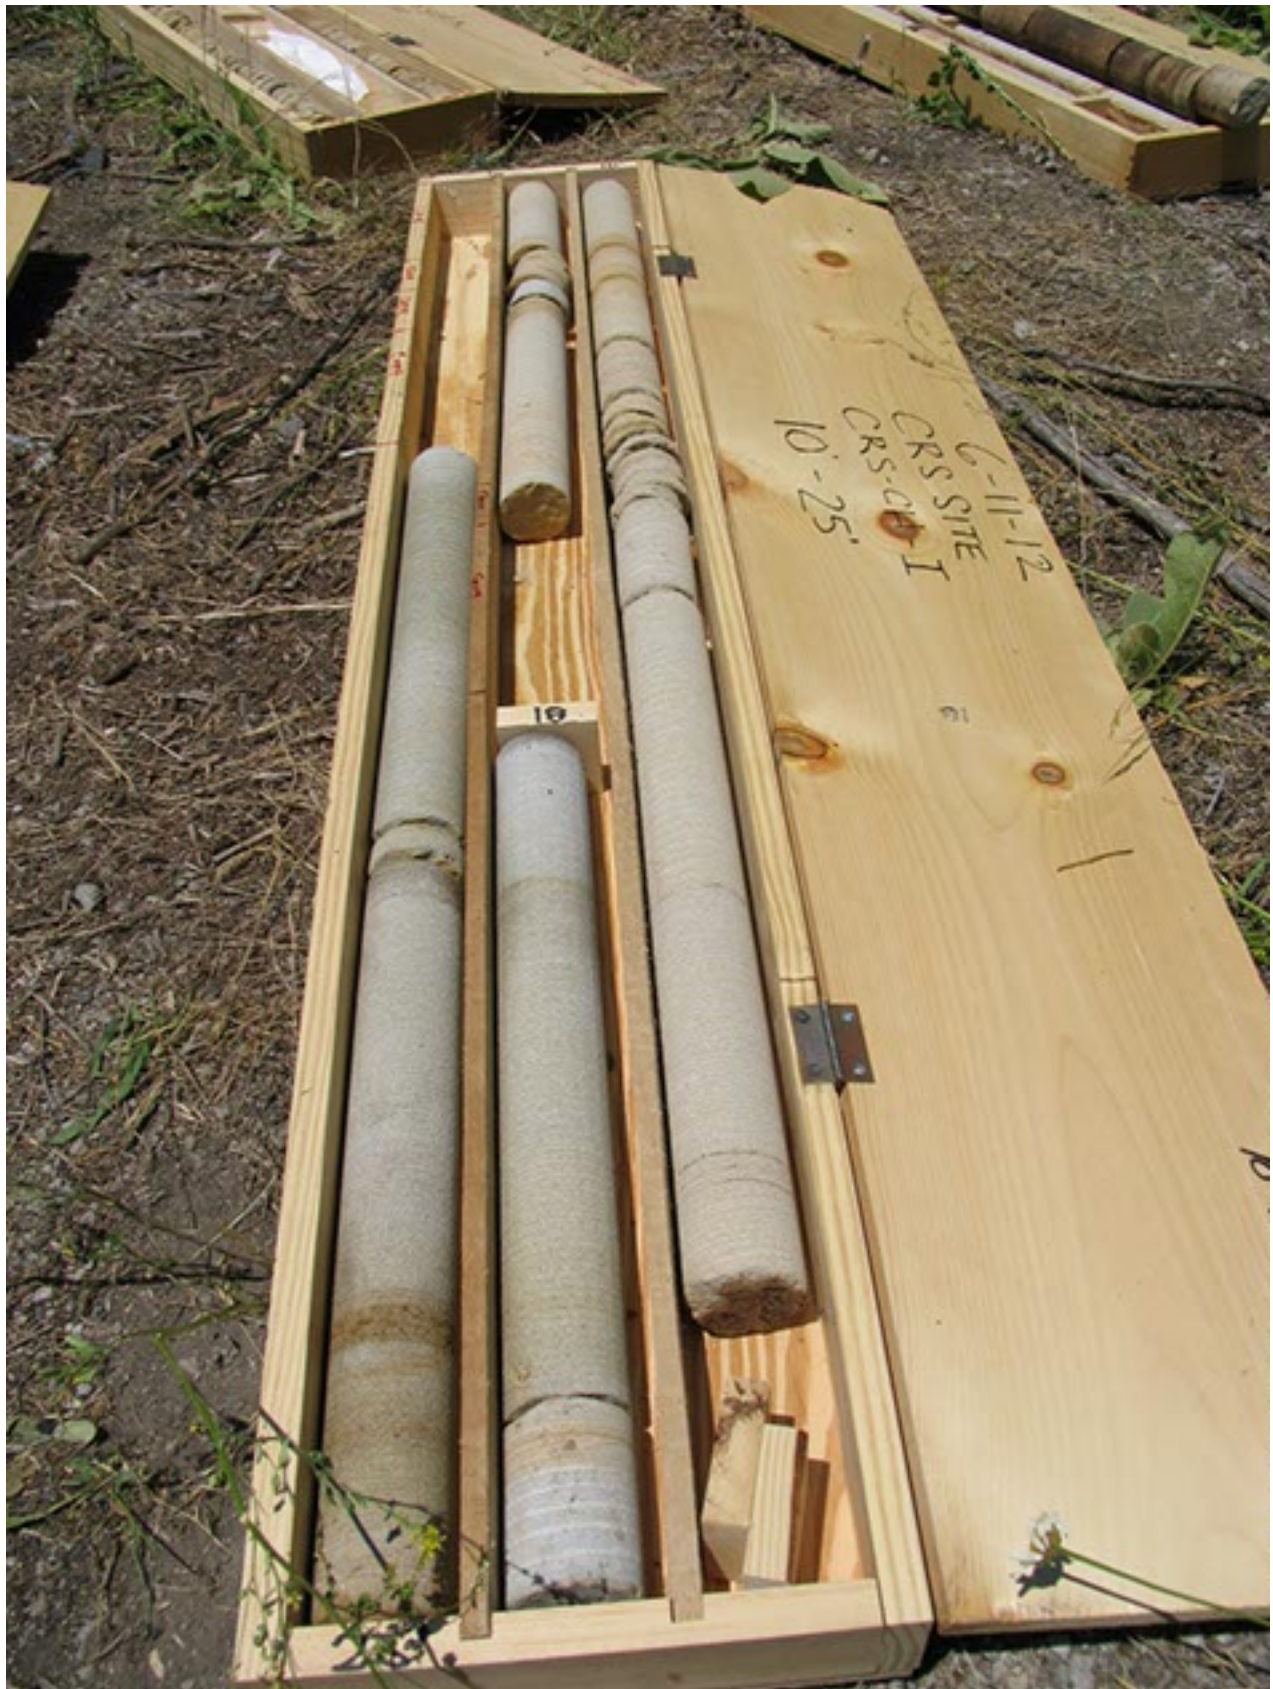
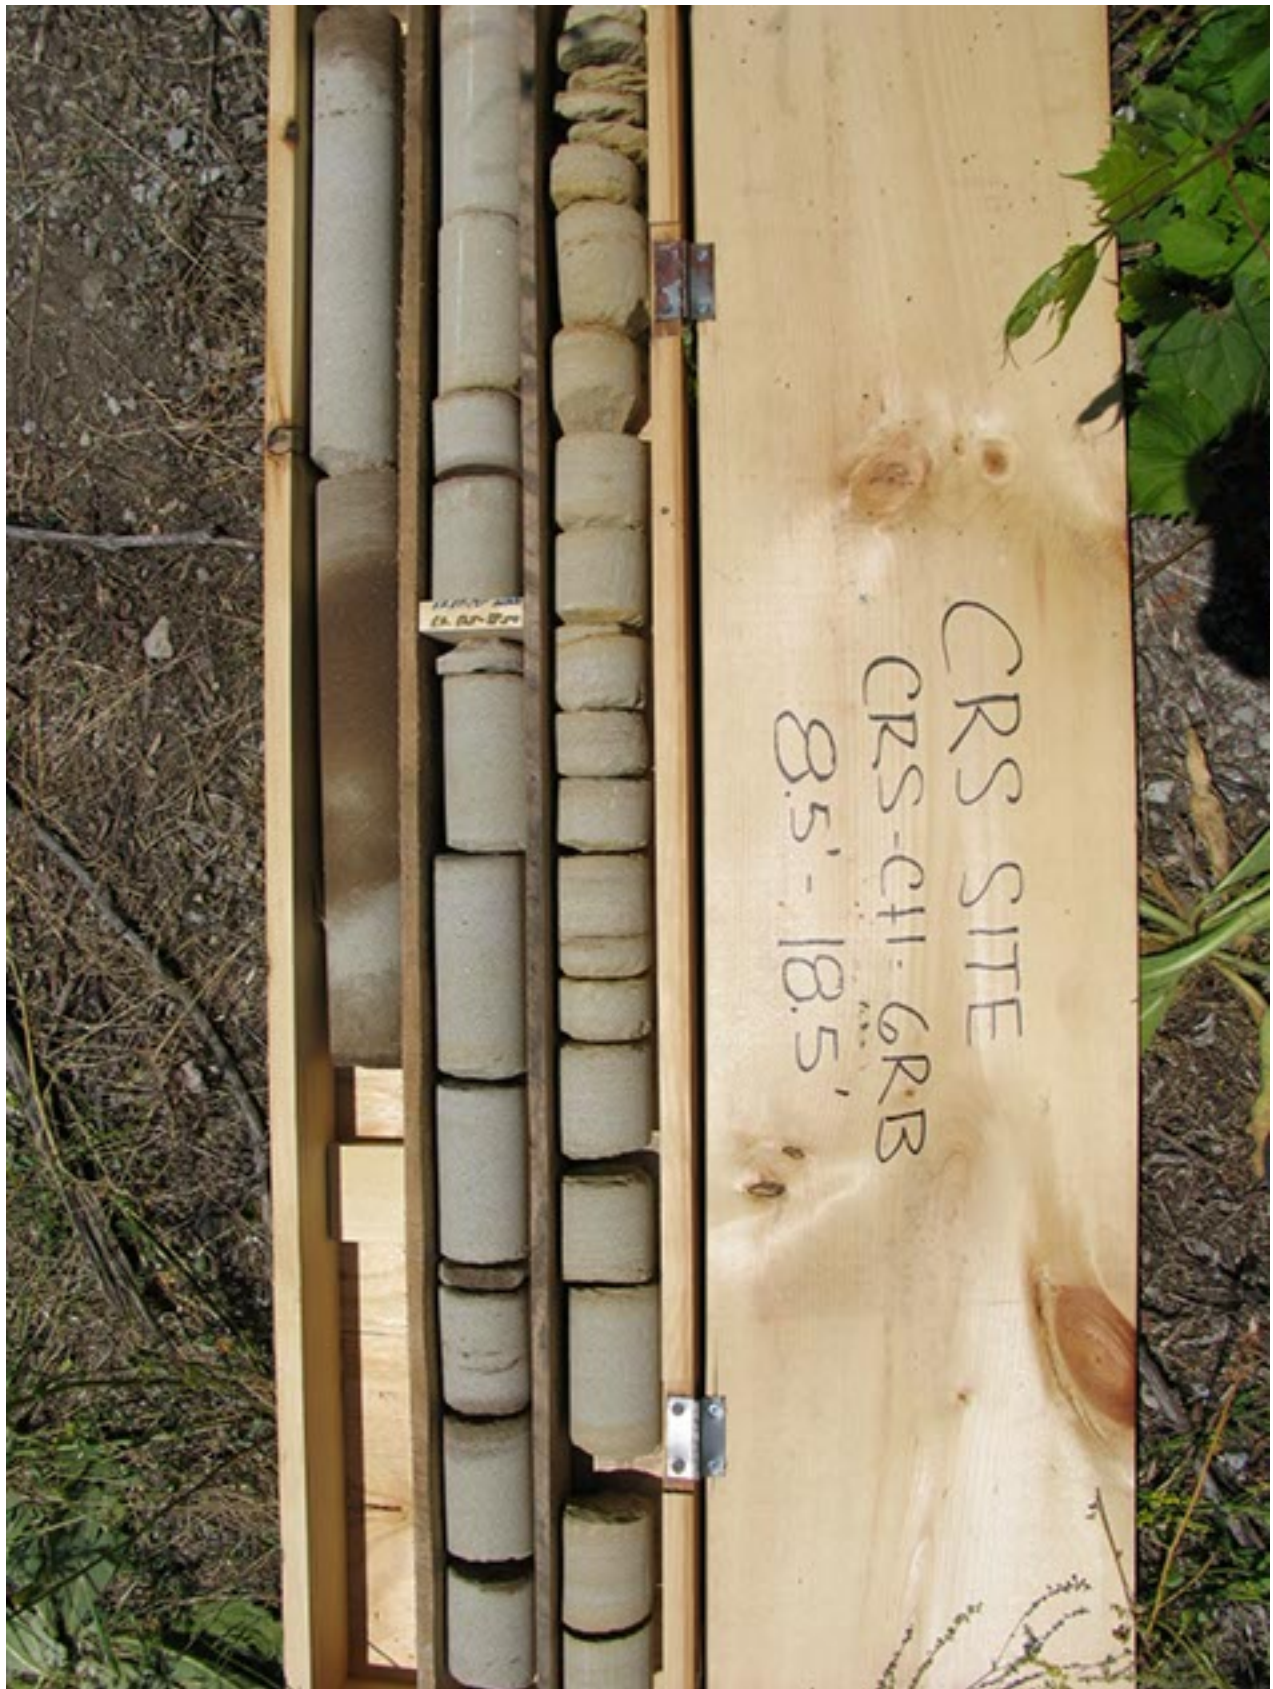
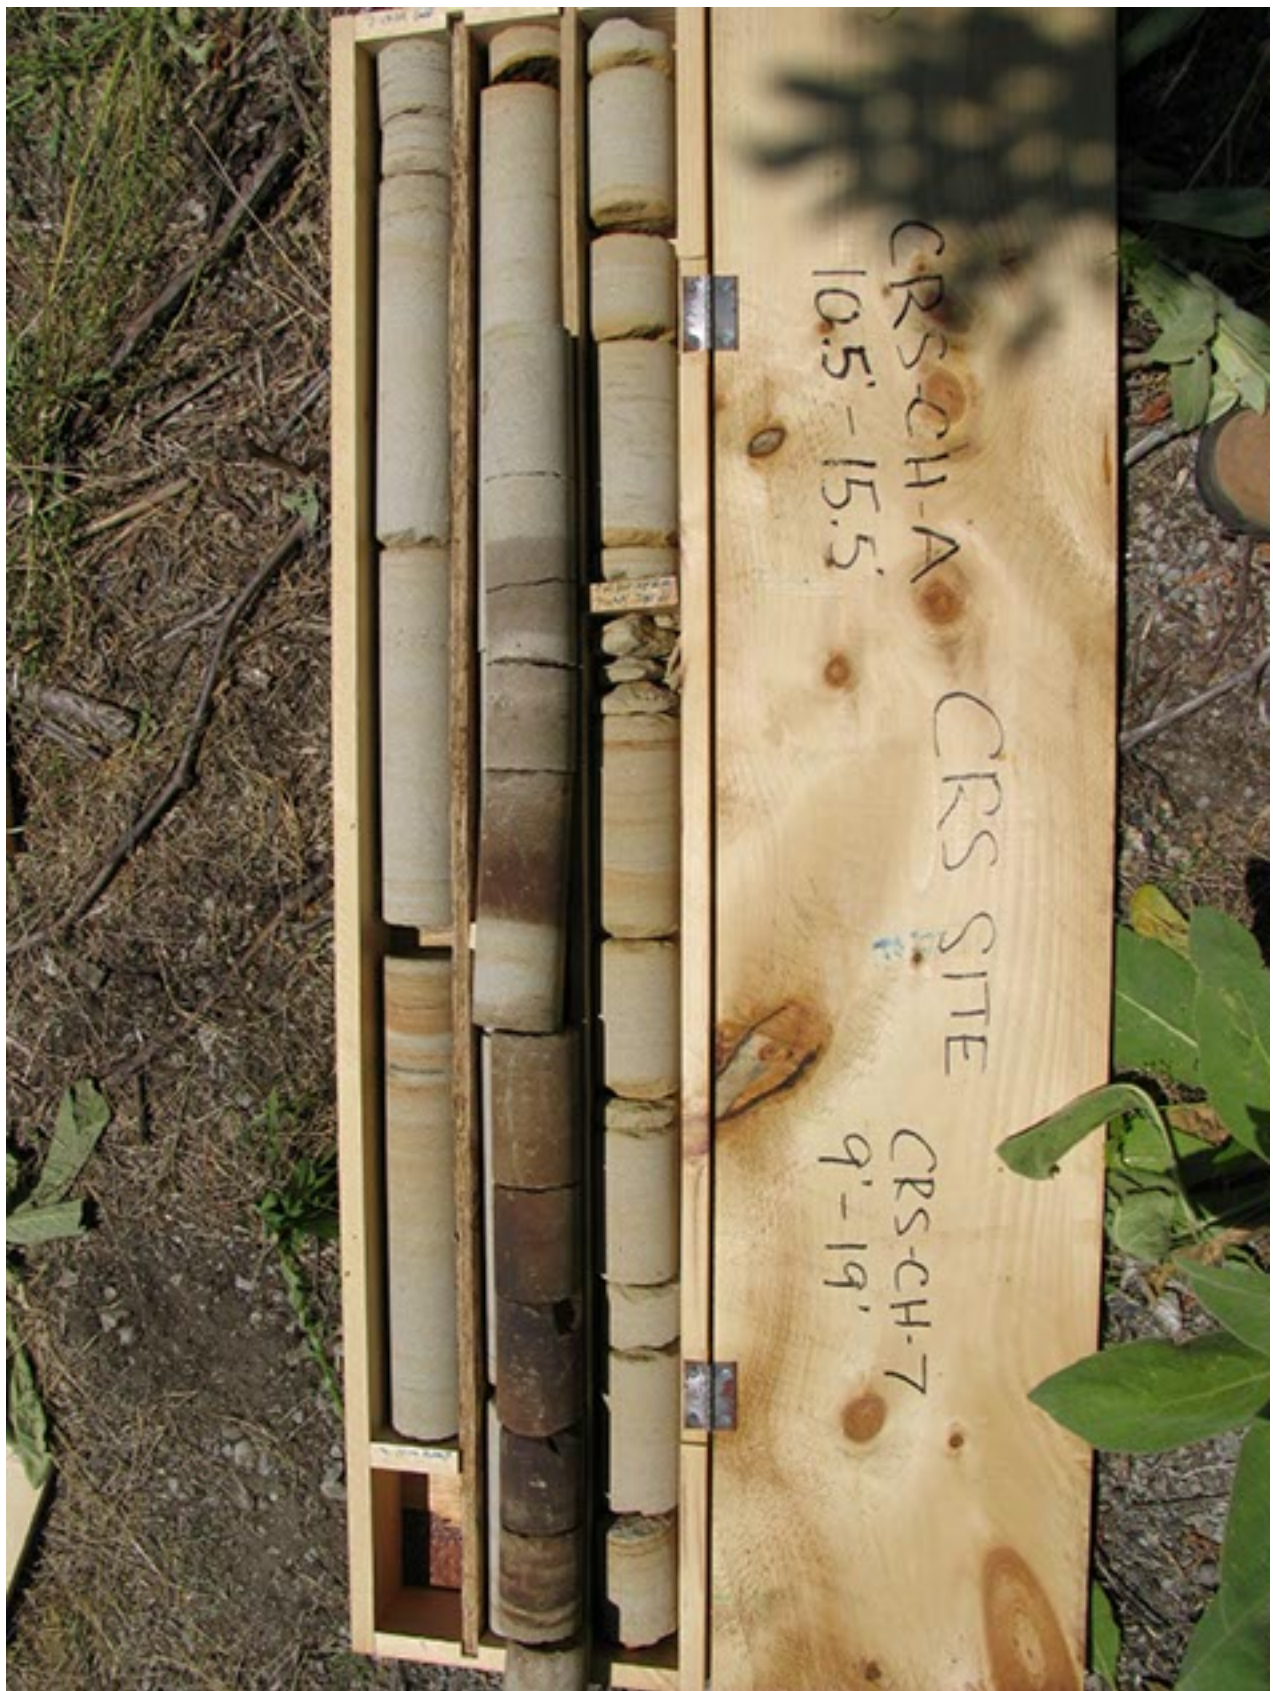
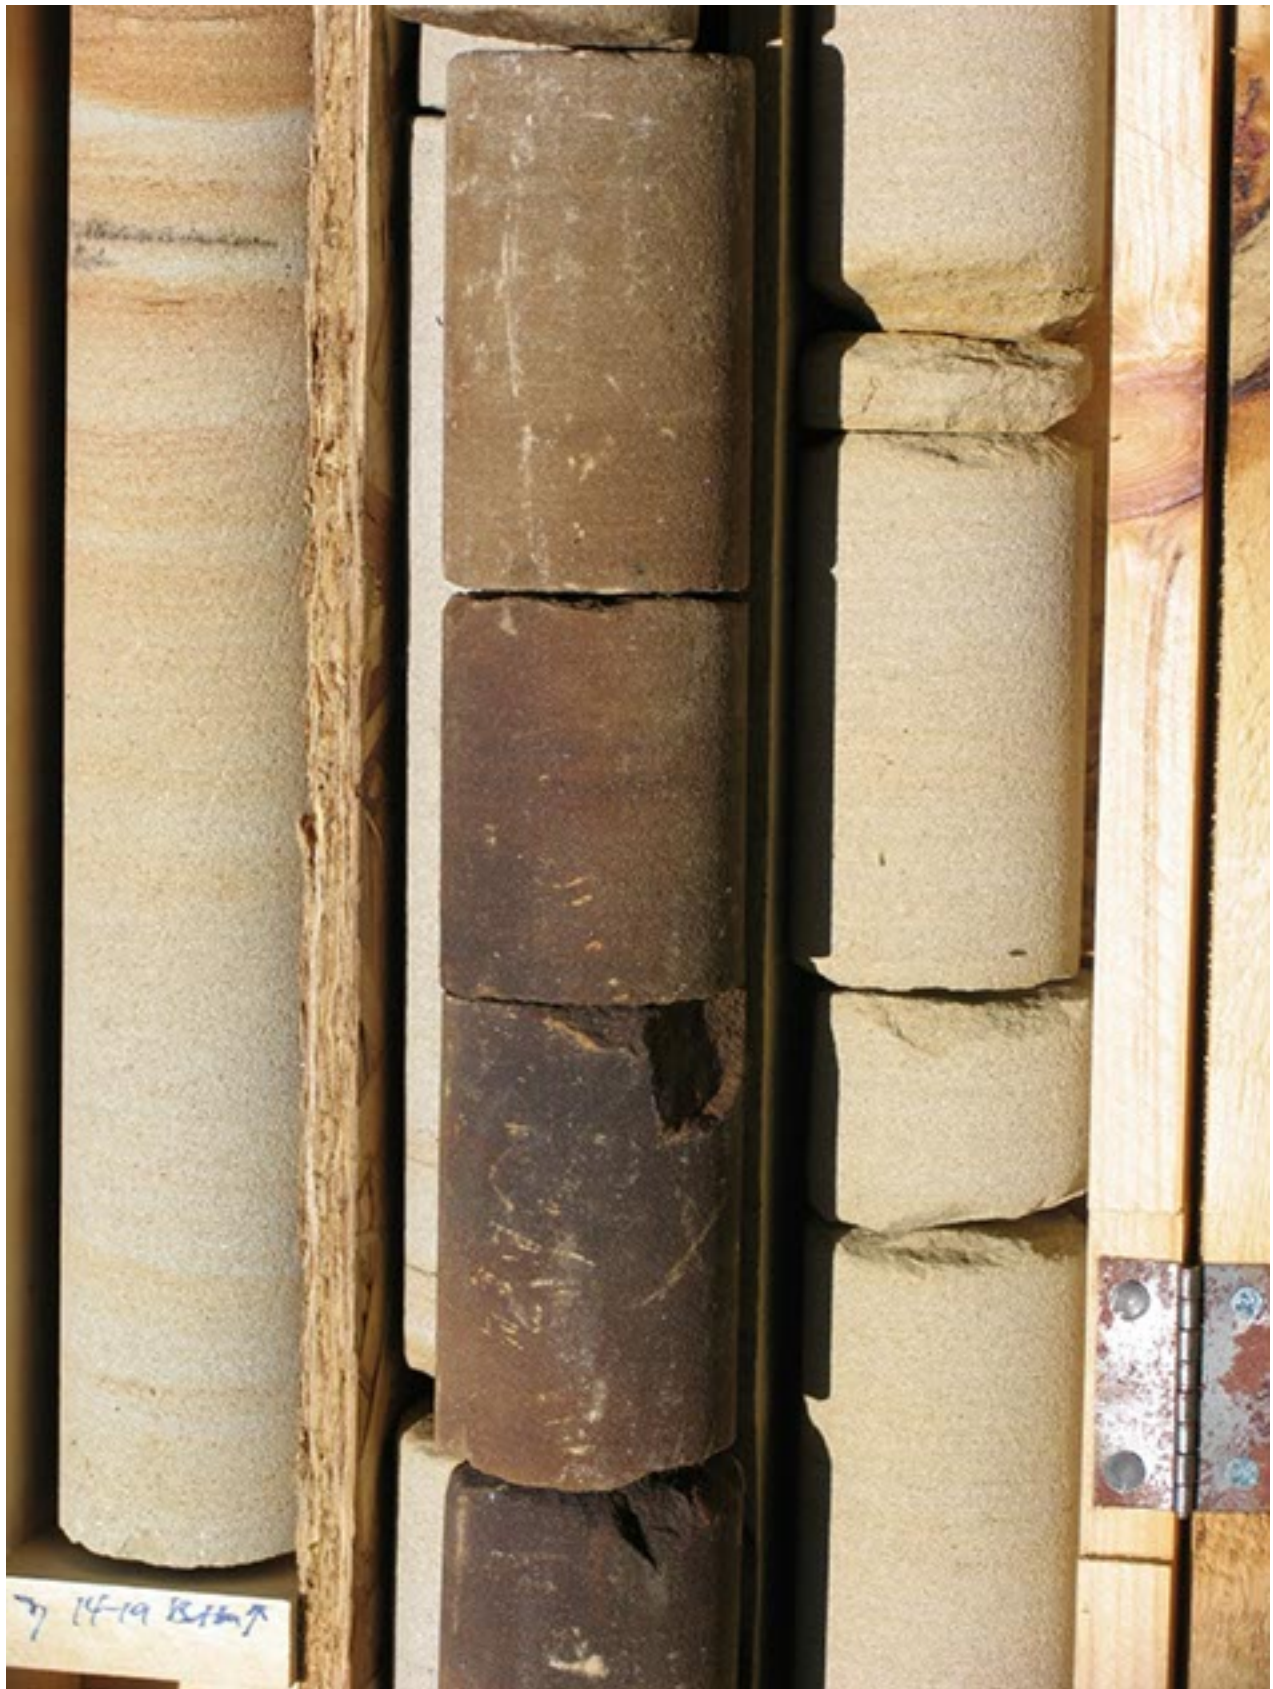
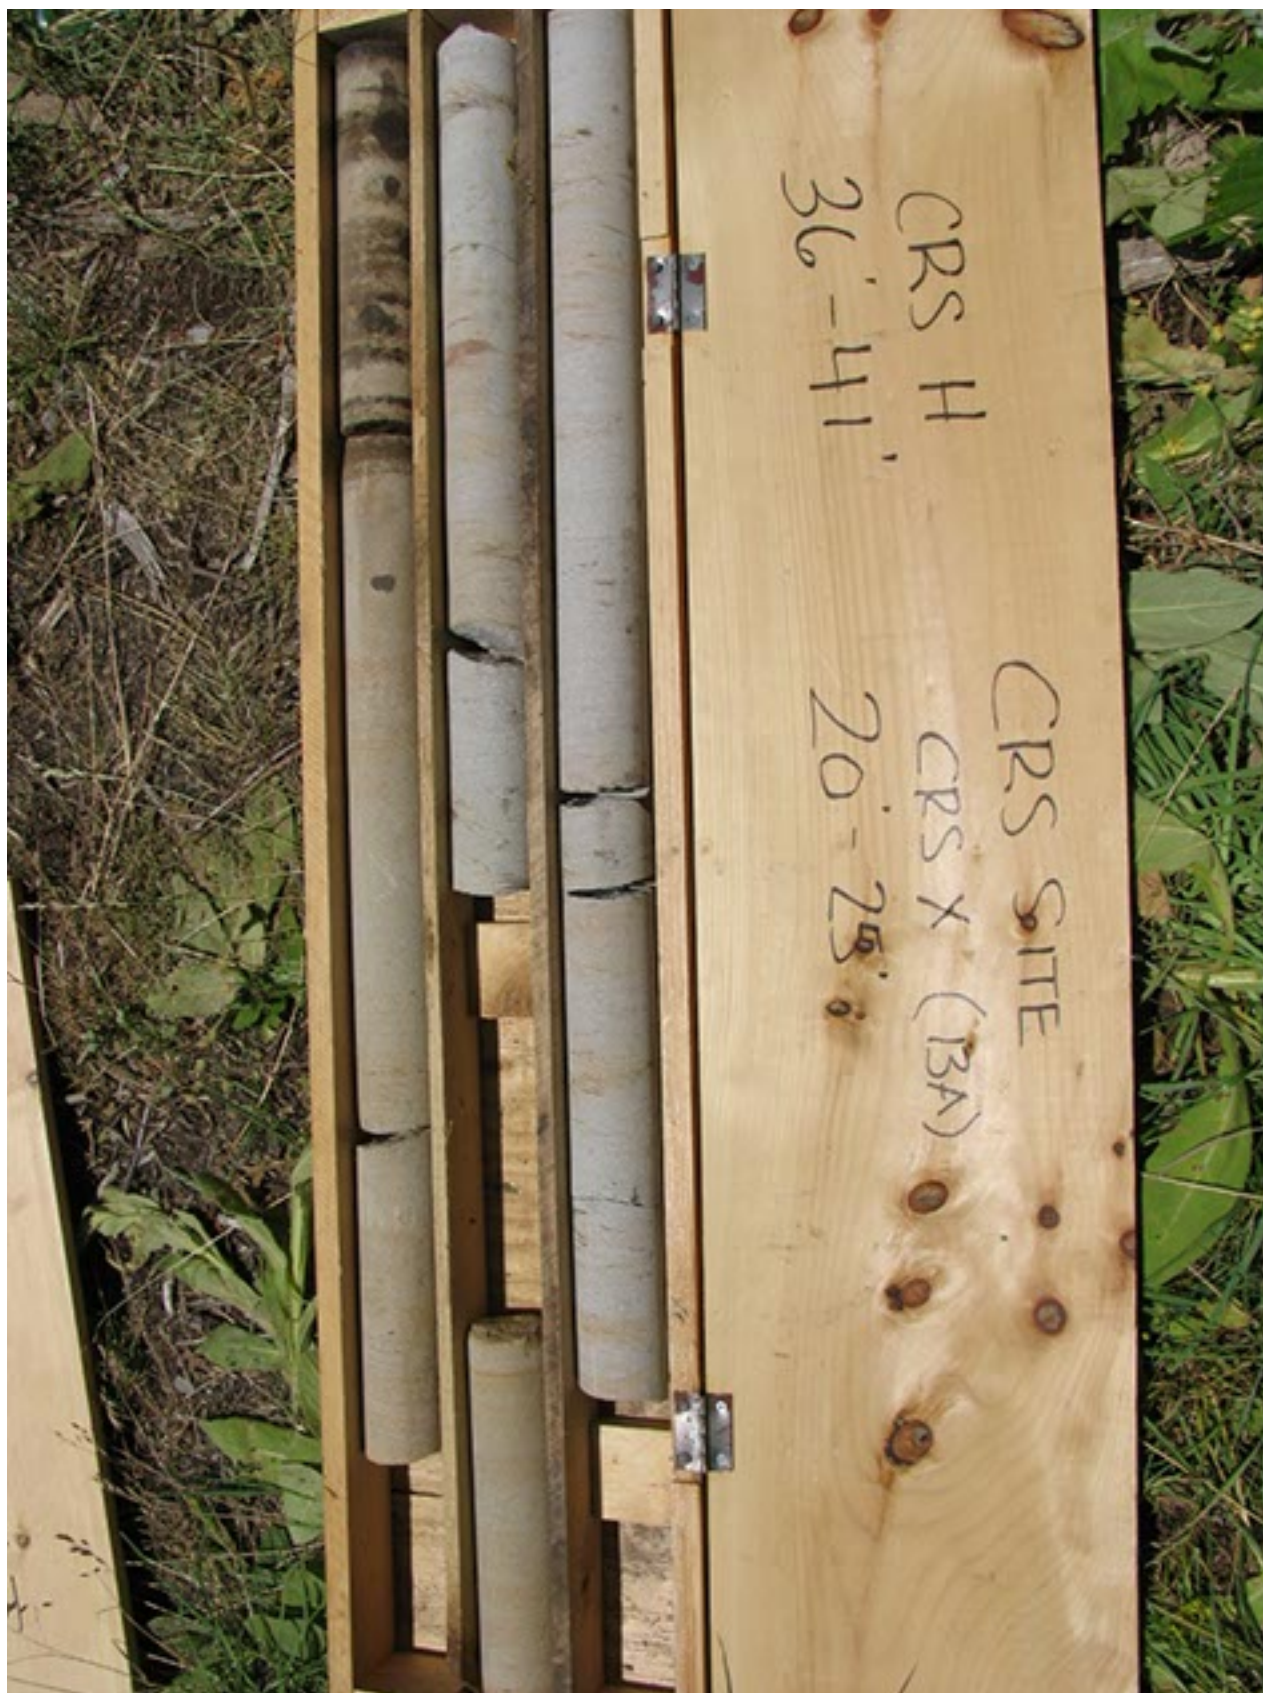
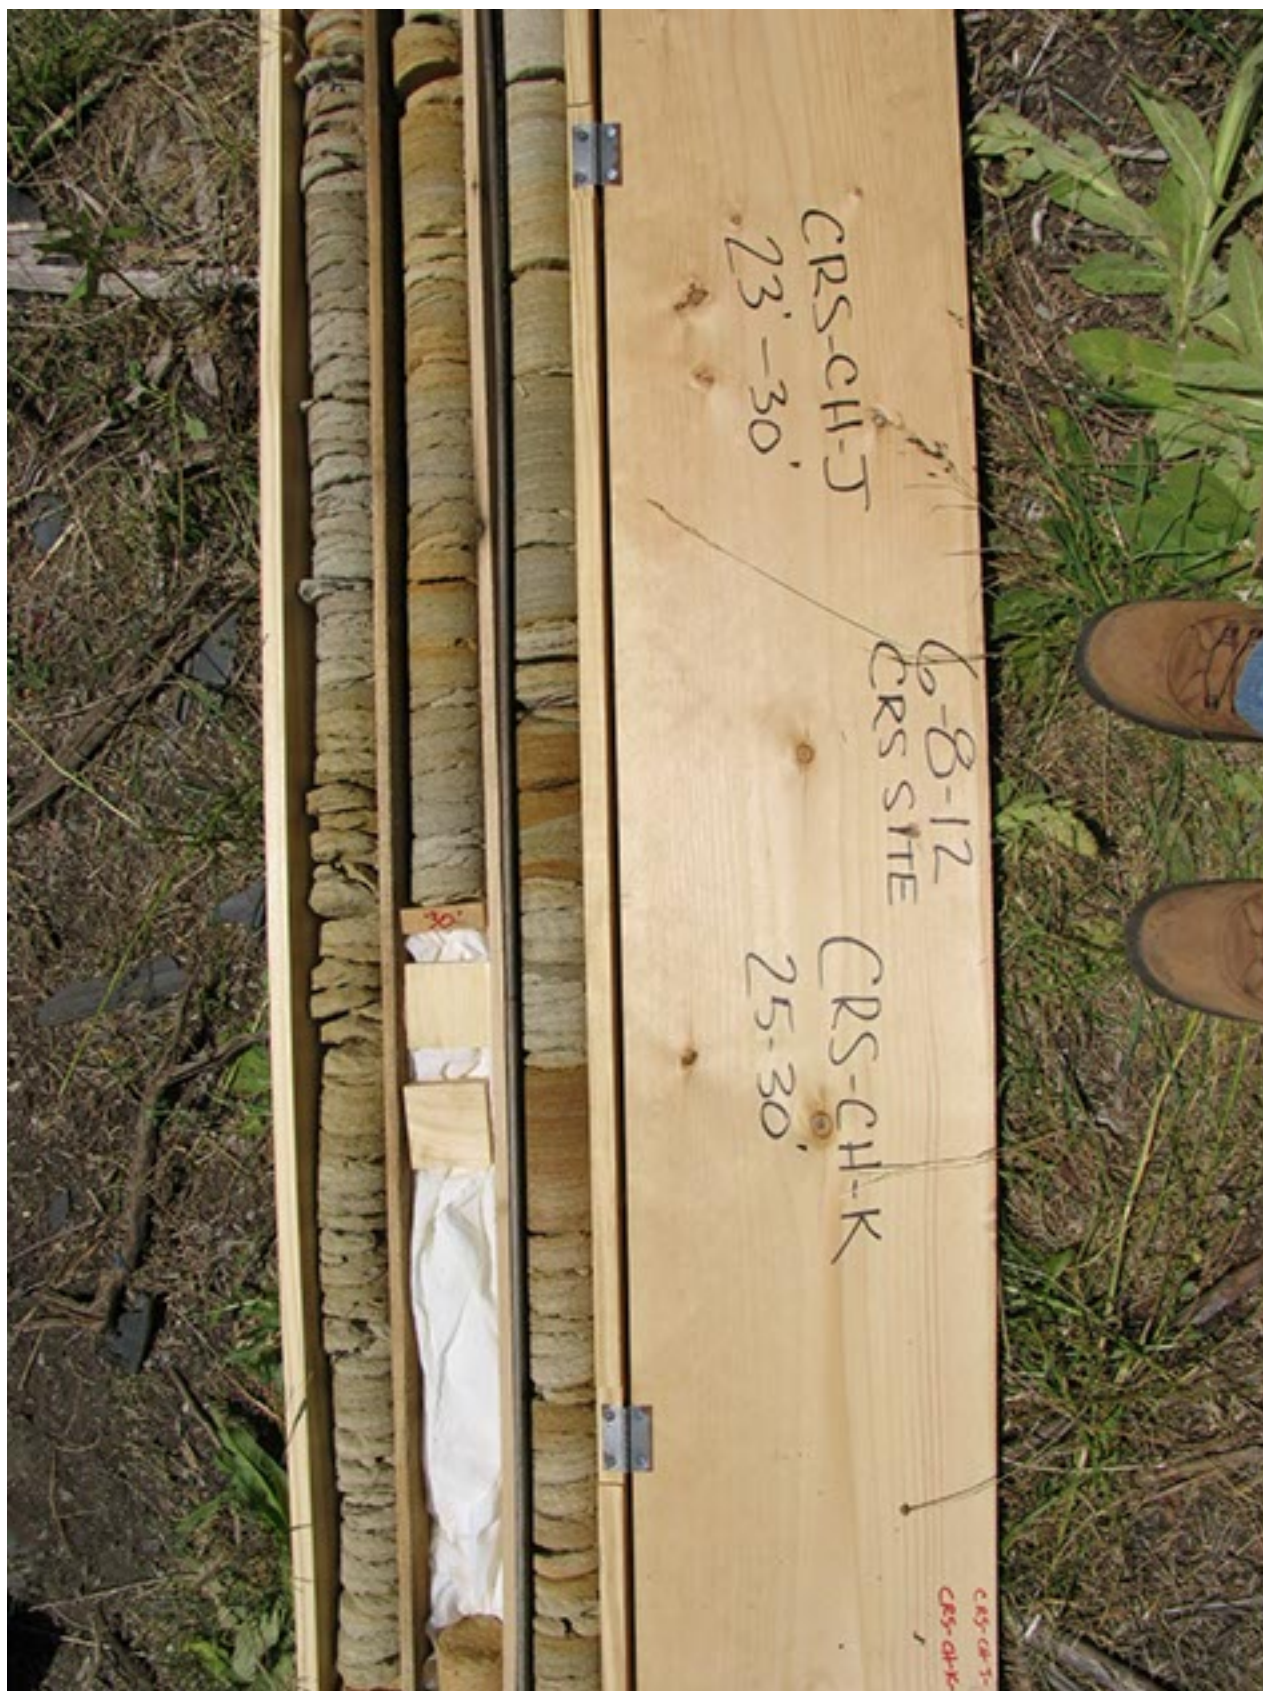
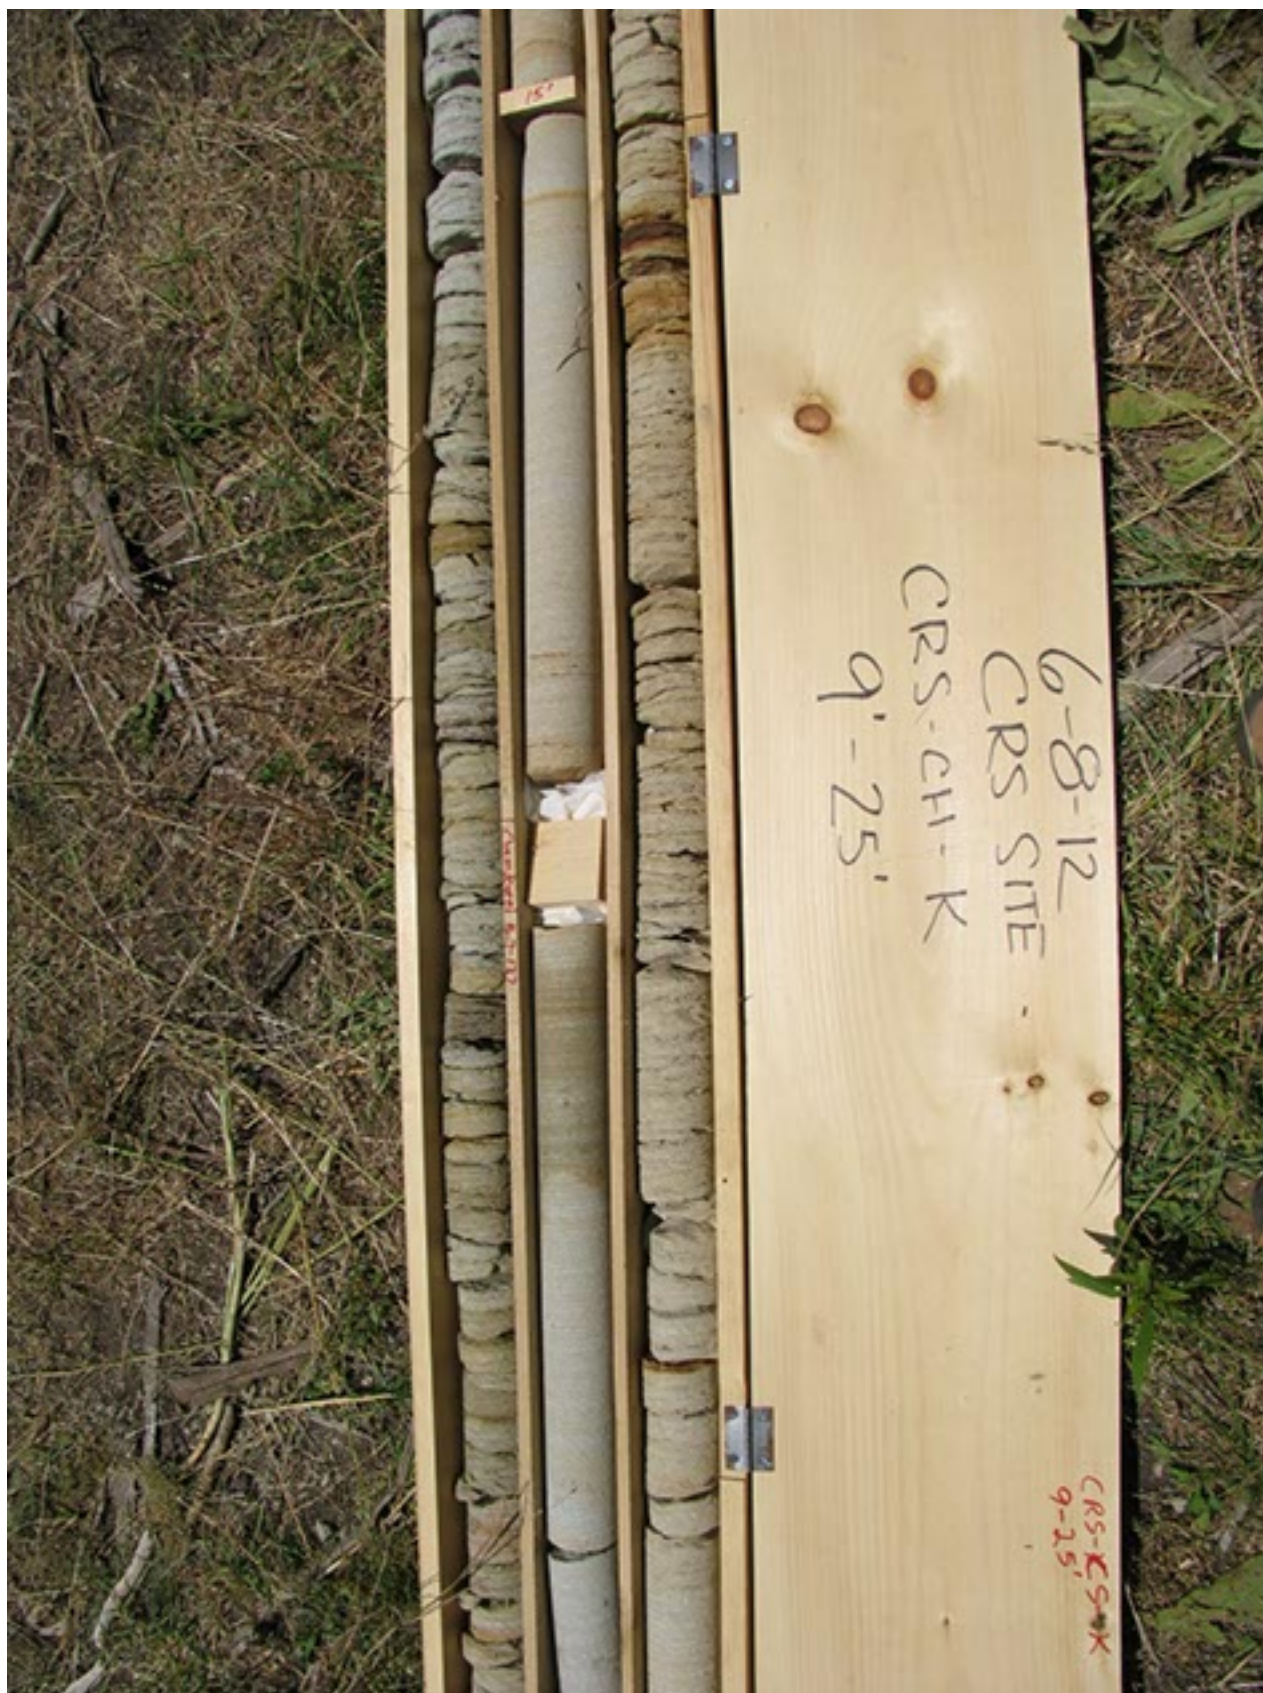
Bedrock cores - J - extremely fractured, K also, compared to others. Cores I, J, K did not have complete sections of NAPL-impacted rock that were expected but still had acceptable sections for petrophysical analysis. Went 30 ft. down, & want to create core bit, & saw clean rock. Heavy NAPL impacts obsd. ~ 14-20 ft in bedrock. Fracture zones & continuous.

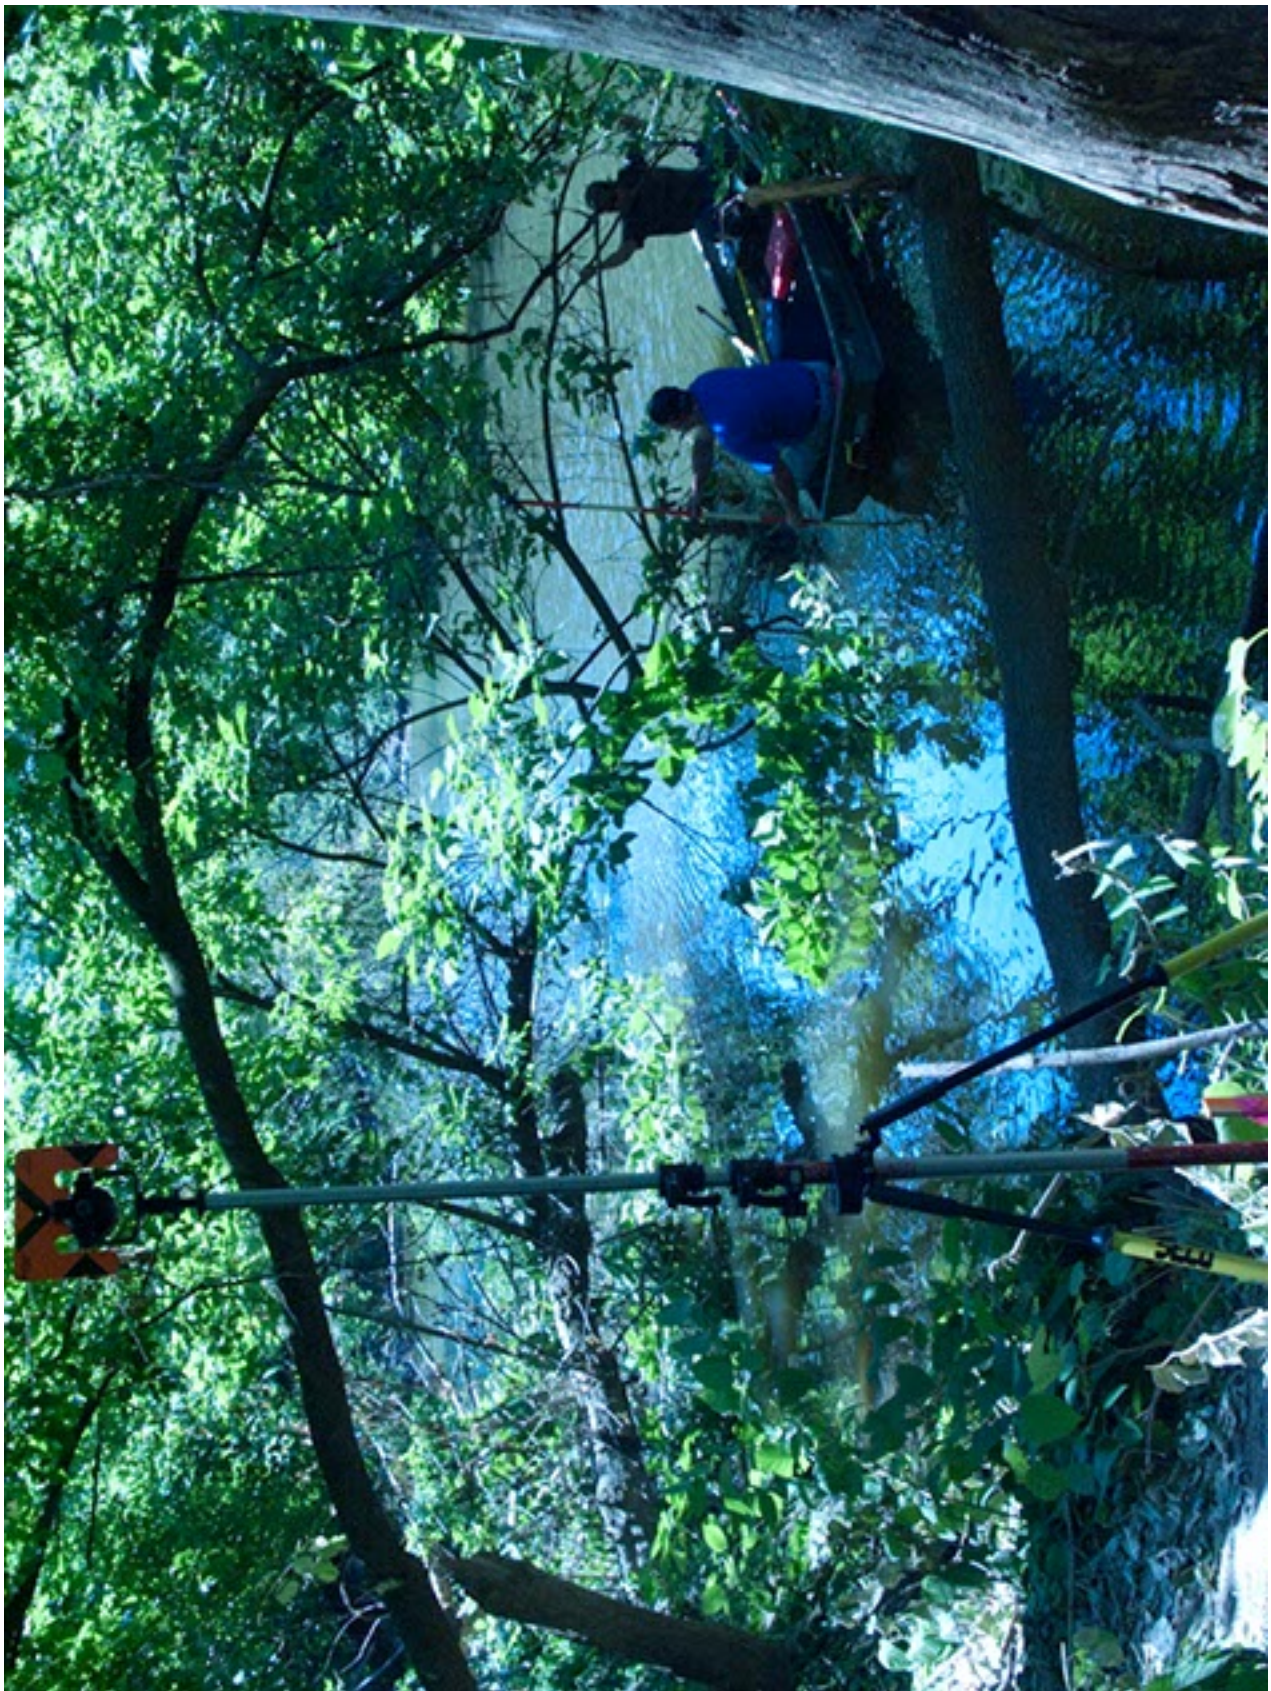
river survey\_2012:6:14.CRW

Finishing river bed survey today (filling in points). Surface  $H_2O$  sampling is complete. Seeps marked already.

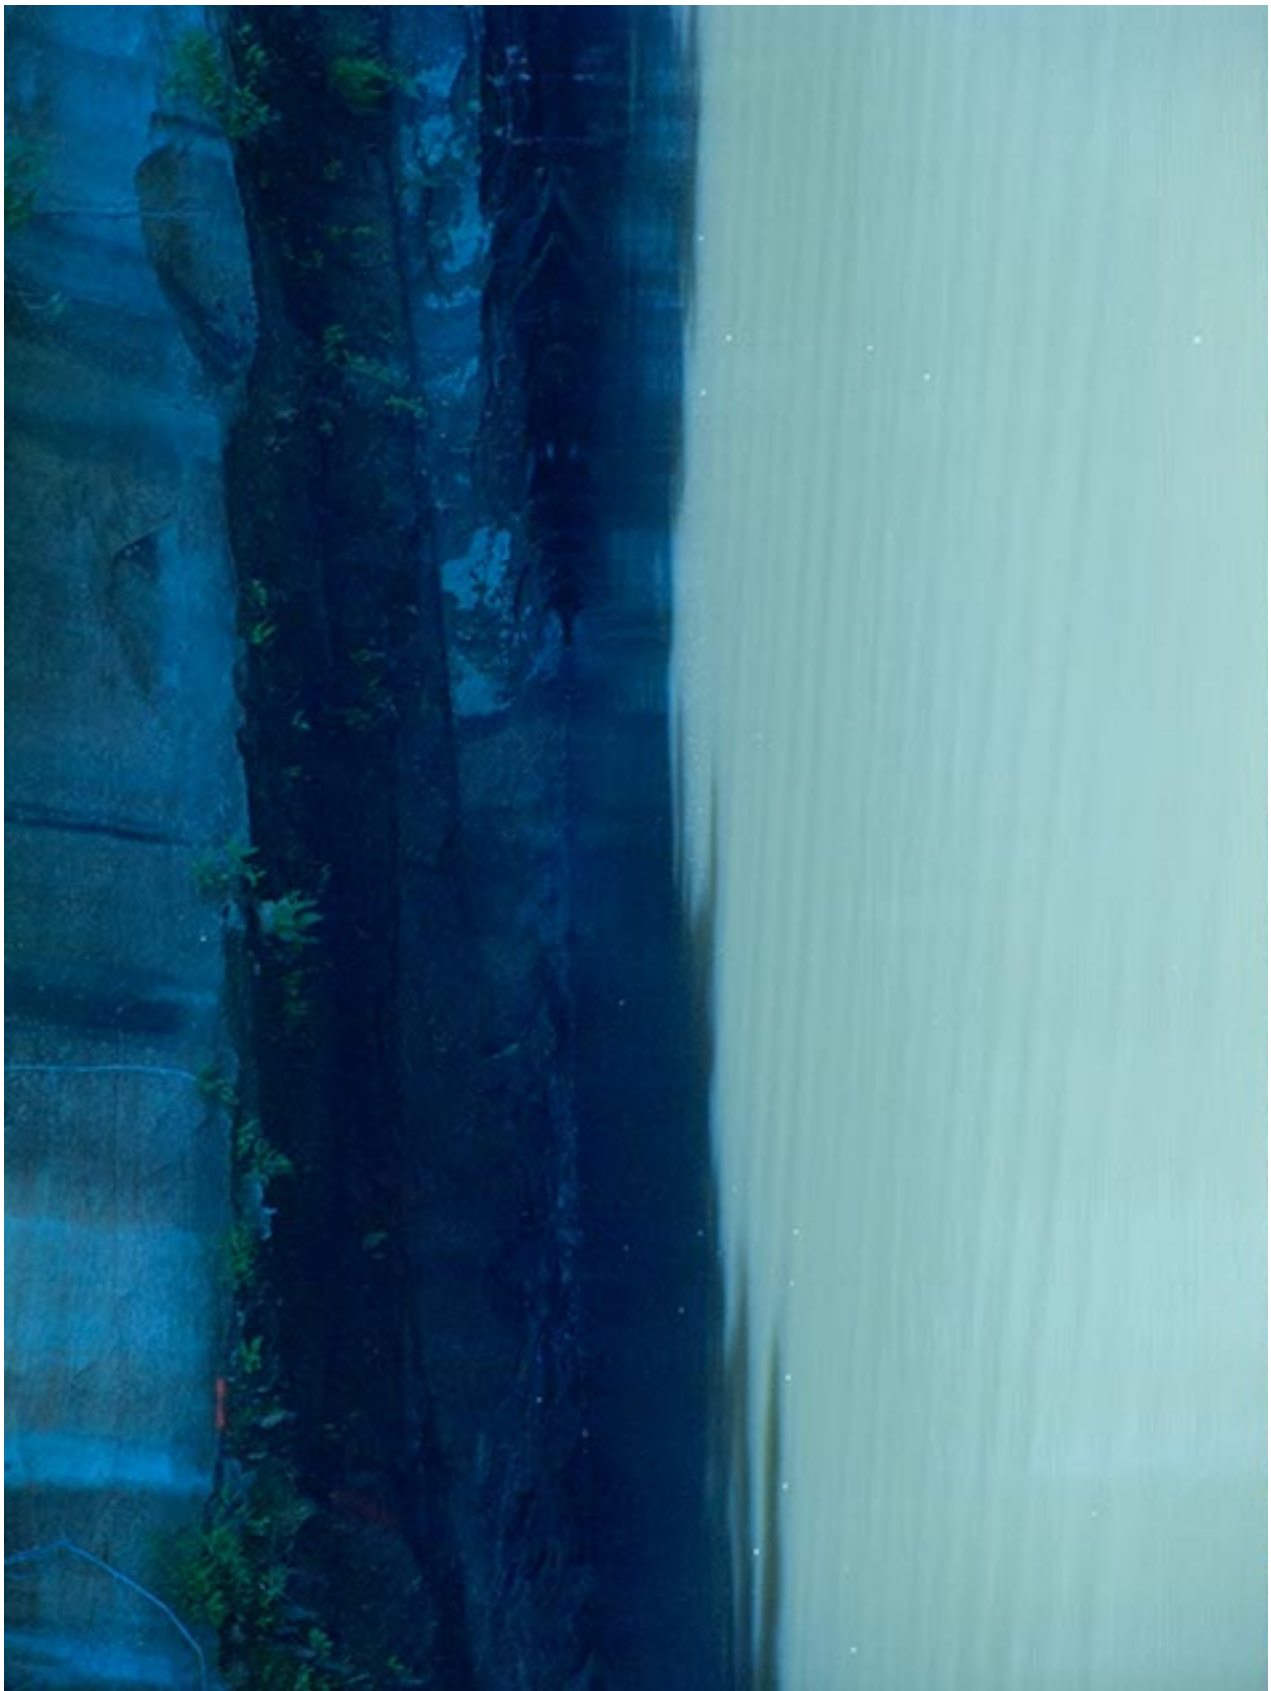
seep west bank Black River\_2012:6:14.CRW

Seep observations used for permeability measurements. Due to nature of seeps data will be mostly qualitative. E.g. long, slow zones on east bank south.
